BARN-FIND FIRE-UP

We've all been tempted to buy a motor that hasn't turned over for years, but how hard is it to get one running? We gave it a shot with nothing more than some commonly available tools and products

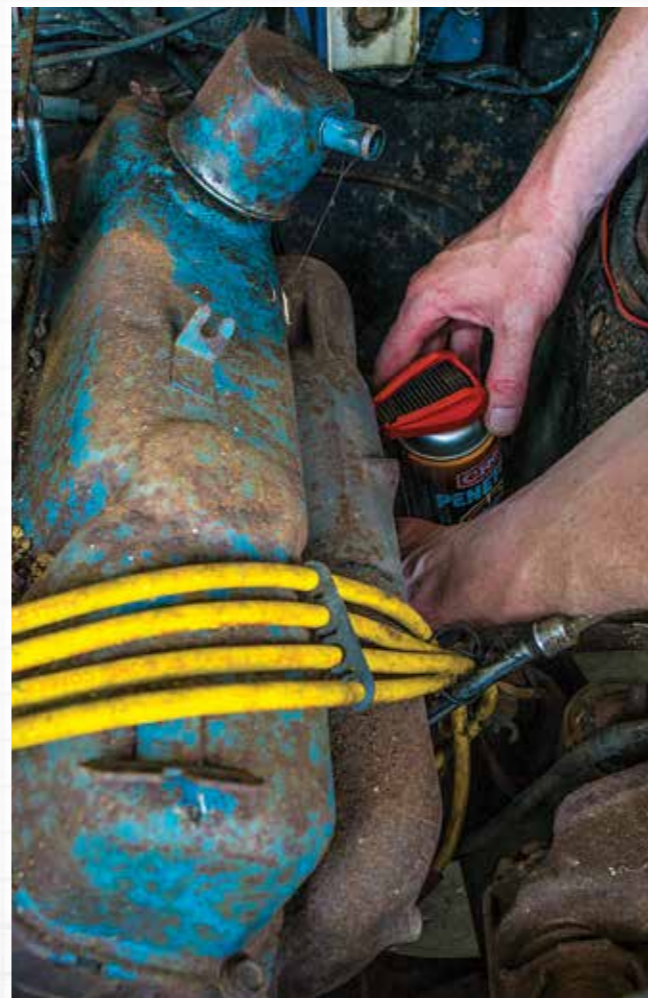
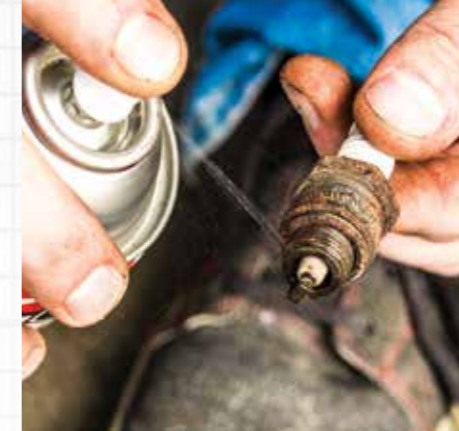
The engine you see here apparently last ran around five years ago; however, before that, it was sitting for an extended period of time, so it's unknown how long it was truly static for — let's just say that it was long enough for it to need to be started correctly. Thankfully, all you should need to fire such an engine into life is a bunch of readily available tools and products — something we had on hand, thanks to CRC recently sending us a heap of different products with the aim of showing people that there's far more to its range than the 5.56 with which the CRC name is commonly associated. One of the biggest issues with an engine that hasn't turned over for some time is rust forming on the rings or within the cylinder bores. Even if the

engine hasn't seized, spraying a decent amount of penetrating oil, such as CRC Penetr8, is a great way to form a barrier of lubrication within the bores and help to free any seized components. While doing this on an engine removed from a vehicle is relatively easy, doing it with the engine in is a touch harder, thanks to the tight confines of the engine bay. Fortunately, Penetr8 has a long built-in flexible nozzle. Not knowing whether or not our engine had seized but being prepared for the worst, we decided to spray it with Penetr8 a few times over a 48-hour period prior to attempting to turn it over. We also sprayed a fairly decent amount each time, to ensure it got right around the edge of the pistons.

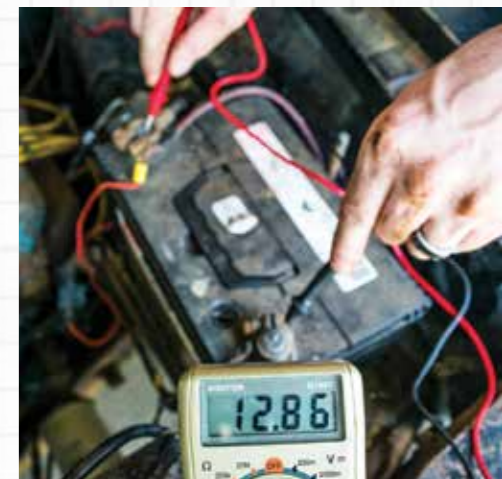
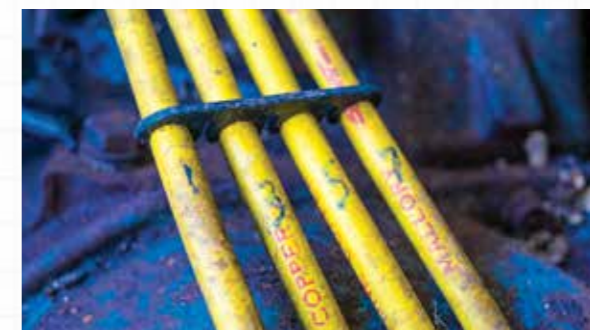
With the spark plugs still removed from the engine, we then attempted to turn the engine over by hand using a breaker bar attached to the crankshaft front pulley; it worked. Rather than aiming for a full revolution, the best practice here is to turn the motor backwards and forwards, increasing the distance with each turn, and that's what we did. While the spark plugs taken out of the engine didn't look too bad, we gave them a quick tidy-up with some fine-grit sandpaper and CRC CO Contact Cleaner before popping them back in the hole — just to be sure maximum spark would be achieved.

After connecting a battery, and waiting to see if smoke would escape from the wiring — thankfully, it didn't — we checked for voltage at the ignition coil. It showed up as 12.8V — a great sign that the electrical system might work. That said, to be sure, we left a spark plug out of the hole but attached to the ignition lead, and attempted to crank the engine over. Much to our delight, not only did a twist of the key coax the starter motor into life, but the spark plug also quite clearly ignited. In cases like this, it's advisable to check that the ignition timing is roughly correct, and a timing light is necessary to do this. However, since this engine was only being fired up to ensure it could run 'as is' — without opening it up — and spark was being generated, it wasn't deemed necessary to fine-tune the ignition timing. If the engine did not run after we added fuel, the ignition timing would have been the first thing to look at.

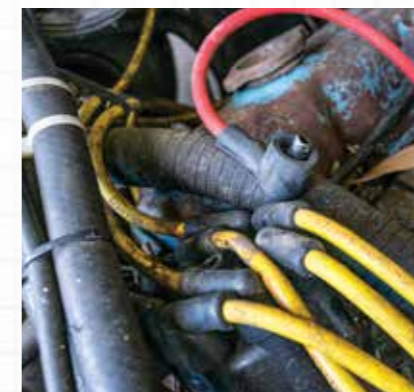
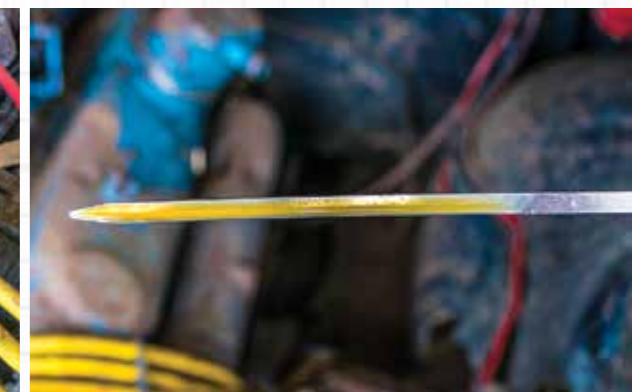
Even so, it was still decided that we should at least check certain things were OK. Knowing the big block Mopar firing order to be 1, 8, 4, 3, 6, 5, 7, 2, and bearing in mind that the distributor rotor spins counter-clockwise on these engines, we checked the ignition leads before reattaching them to ensure they were at least in the correct order.

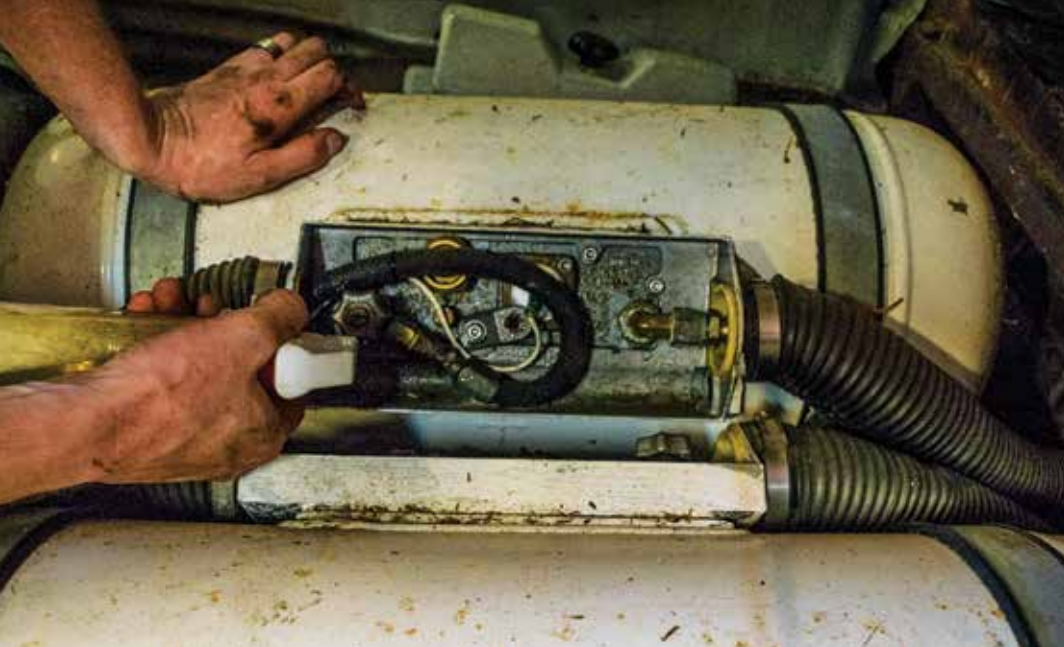
The next step was to build up oil pressure — we had previously checked that there actually was oil — so the coil lead was disconnected from the distributor before we attempted to crank the engine over by turning the key. After 30 seconds or so of solid cranking, we were confident that enough pressure had been built to lubricate the bearings. Ideally, we would have run an oil-pressure gauge on it — and this should be done, just to be sure — but we took the risk that the oil pressure was OK. >

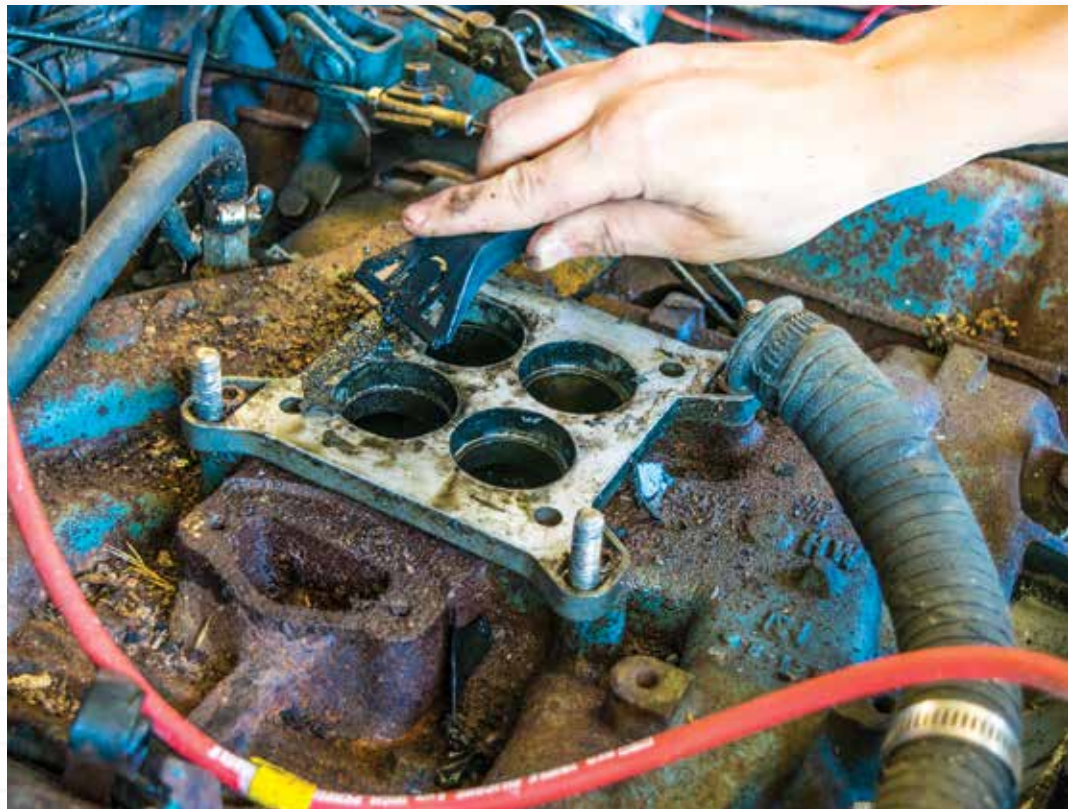
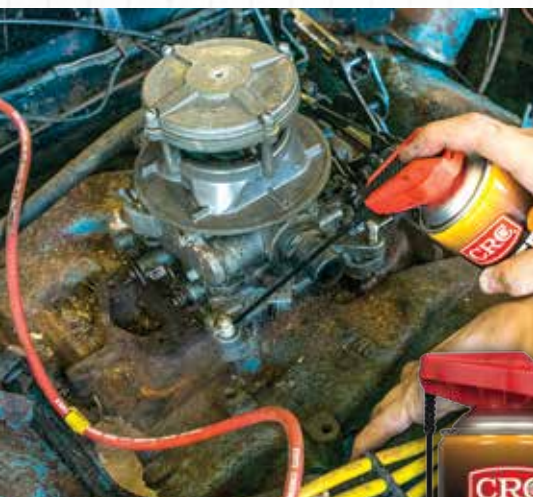
With a normal carburetted motor, it's easy to see whether fuel is present at the carb by depressing the throttle linkage and watching/hearing the atomized fuel spray into the venturis. However, the motor we were attempting to start had been converted to LPG many years before. Our lack of experience with LPG left us a touch in the dark here, although the principle is fundamentally the same.

With the taps for the LPG system turned on, we could hear gas filling the lines. We did a quick check for any leaks, using soapy water in a spray bottle, before deciding to kick it in the guts. A quick spray of CRC Engine Start into the LPG carburettor while we cranked the engine over was to no avail; while gas was present in the lines, it clearly wasn't making it to the carb. We did consider trying the CRC Clean R Carb we'd been given, but figured that the problem was more terminal than just a clean-up.

The easy solution was to pull a petrol carburettor off a working engine and set up a temporary fuel supply involving a funnel and some fuel line — a gravity-feed fuel system that can't go wrong. Of course with the motor and car sitting for so long, there's a whole lot more work required to make it driveable than just getting the motor running. As expected, the throttle assembly was seized, so liberal amounts of CRC 5.56 were sprayed into both the throttle cable sleeve and onto the throttle assembly, which soon solved the issue. Ironically, removing the LPG carb was a harder task than expected, due to the amount of rust on the bolts. We used Penetr8 again to help free the rusted up fasteners, and, thankfully, with a paint scraper and CRC Aeroclean Engine Degreaser, the intake manifold's surface was soon clean enough to mount a carb to. >

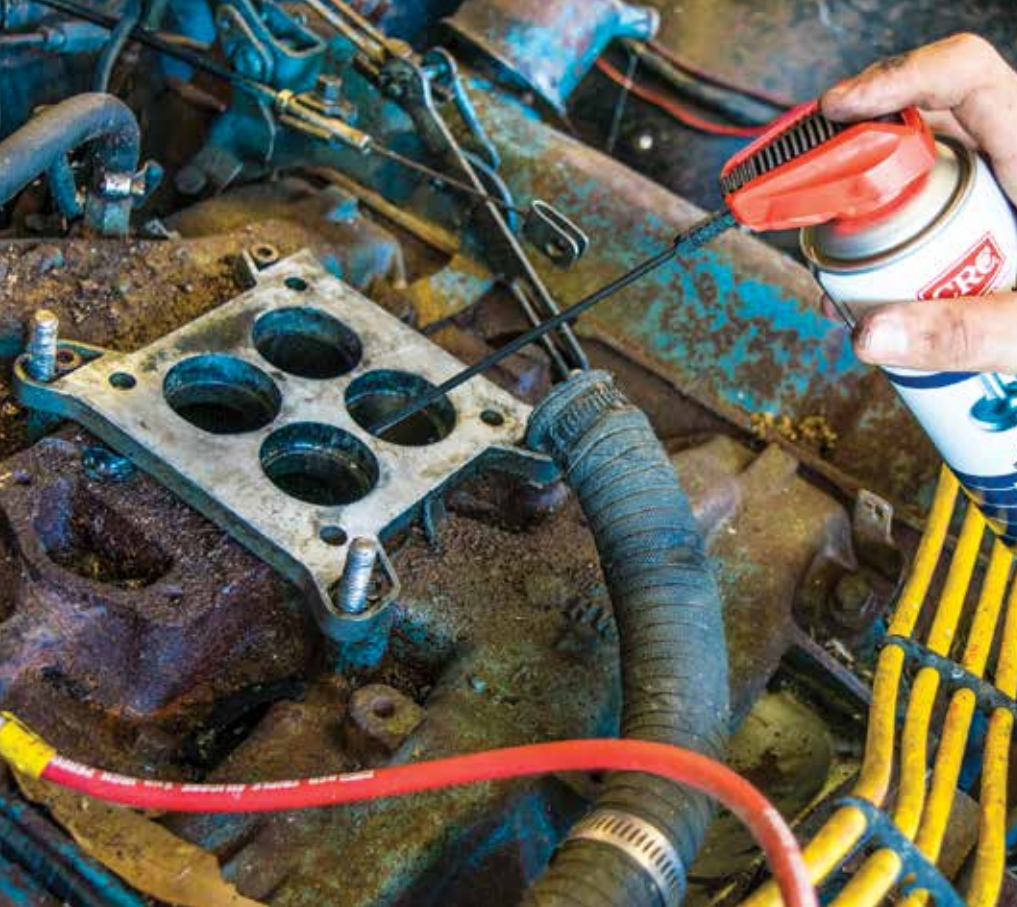
C-BOMB

While the carb was off, we took the chance to spray some CRC GDI Intake Valve Cleaner down the hole. Sure, the engine isn't direct injected — or fuel injected at all — but we'd heard how well GDI [gasoline direct injection] cleaner cleans up the intake valves and valve seats of a running engine and had some on hand, so figured it was worth a shot.

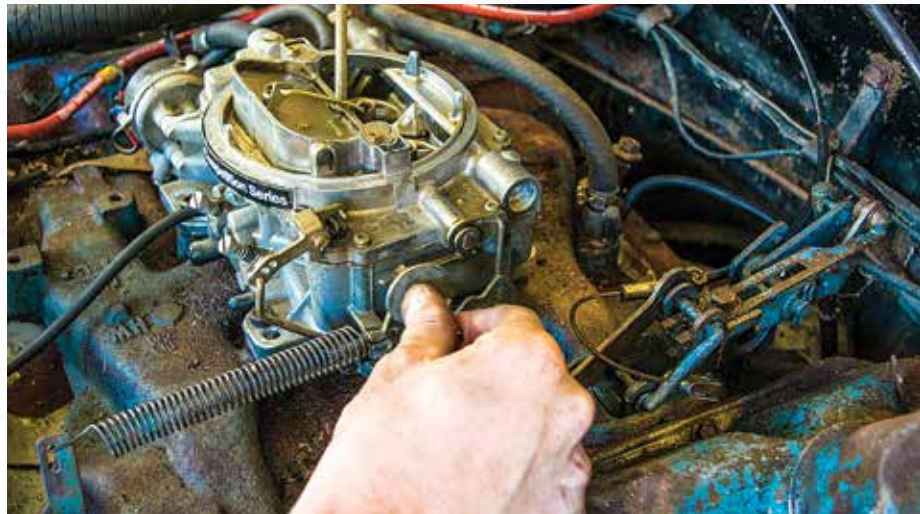
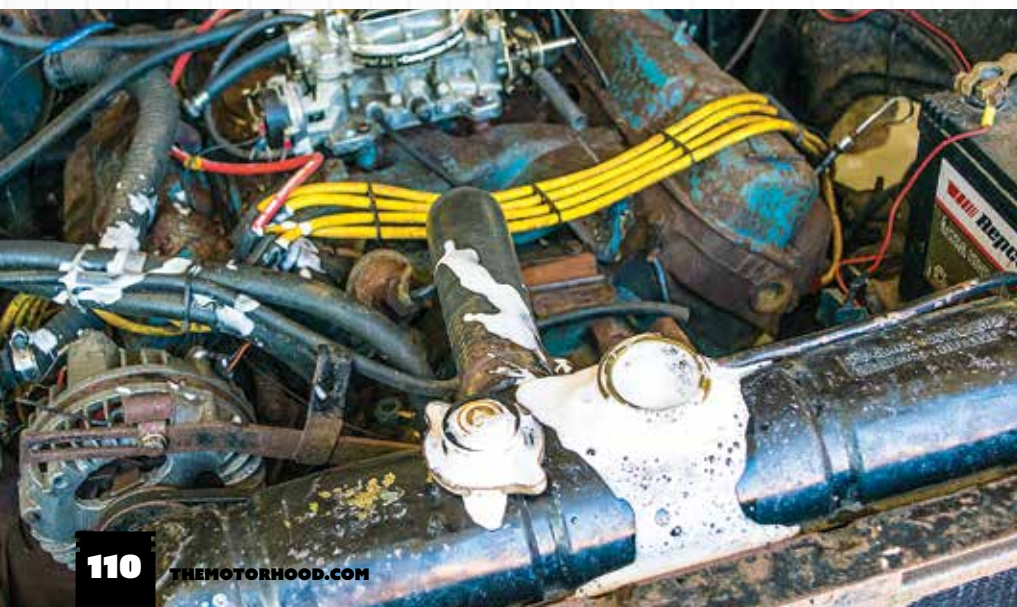
We did not replace the carburettor gasket, as the plan was only to try and get the engine running, not drivable, and the Carter AFB four-barrel was going to have to be returned to its donor engine. The gravity-feed fuel hose was hooked up to the carburettor, and a new line for vacuum advance hooked up.

It was here that we discovered the throttle cable wouldn't quite work with the Carter AFB, meaning it would need to be controlled by hand. No problem — with a more hand-friendly throttle pawl borrowed from the LPG carb, and a shot of CRC Engine Start in the carb, the engine was cranked again, and after several cranks, the engine fired with zero drama. Success!

After we checked the cooling system to ensure it'd be able to run long enough for the engine to get up to operating temperature, it became apparent that the engine had a blown head gasket. We're guessing that's why the car got parked up all those years ago. So, while our goal of getting the engine started was successful, the outcome wasn't the best-case scenario — such is the joy of chasing and working on a barn-find. **VS**
